It's A Steel

Steel windows present a challenge in many restoration projects.

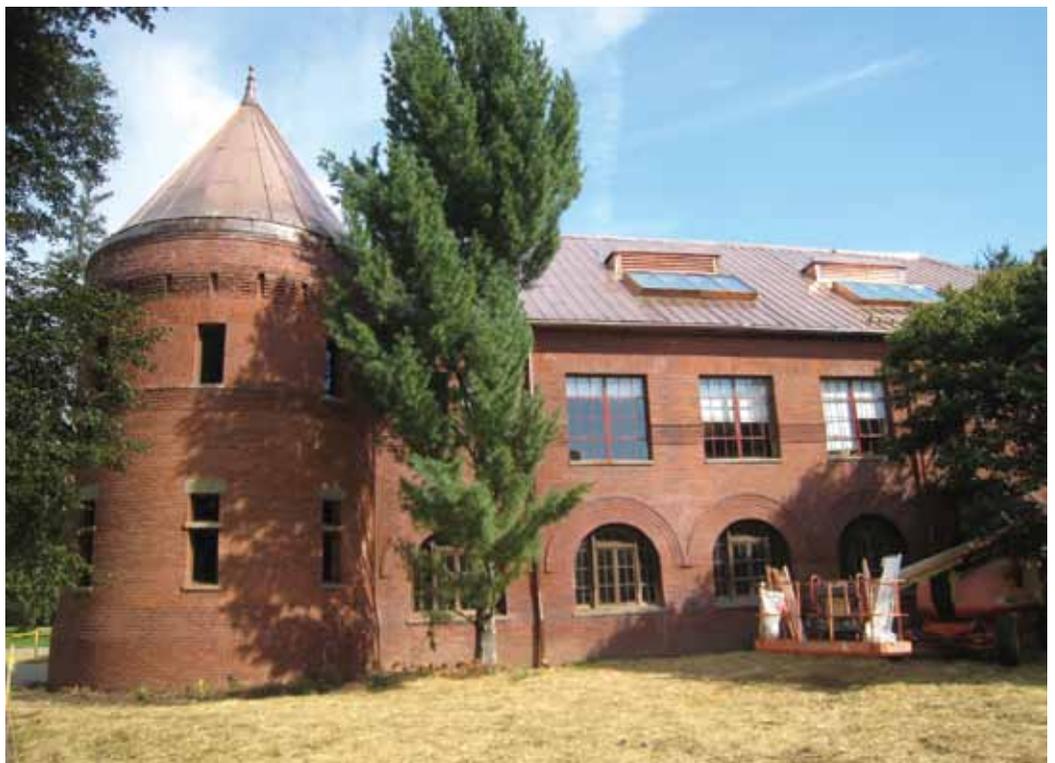
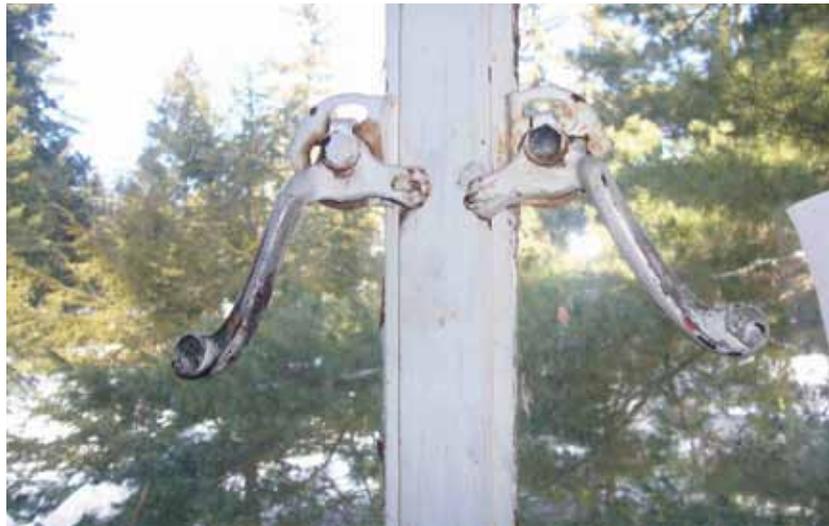
Over the years, the steel windows at Vassar had become encrusted with paint and were inoperable (left). After restoration (above), the windows were as good as new, providing light to classrooms and art studio. All photos: courtesy of Seekircher Steel Window Repair unless otherwise noted.

"The task was to restore the envelope system, the copper roof and the masonry," Horst notes. "The windows – both wood and steel – were a bit of a challenge. There was no question about the wood windows – they had to be replaced. At first we decided to replace the steel windows, but after further investigation, we found that the steel was in good condition; the paint and the glass were not."

"The steel windows at Ely Hall were in fair condition, needing only to be scraped down, primed and painted," he notes. "So we restored them all in place. Fortunately, Seekircher also had a collection of historic hardware for replacements where needed."

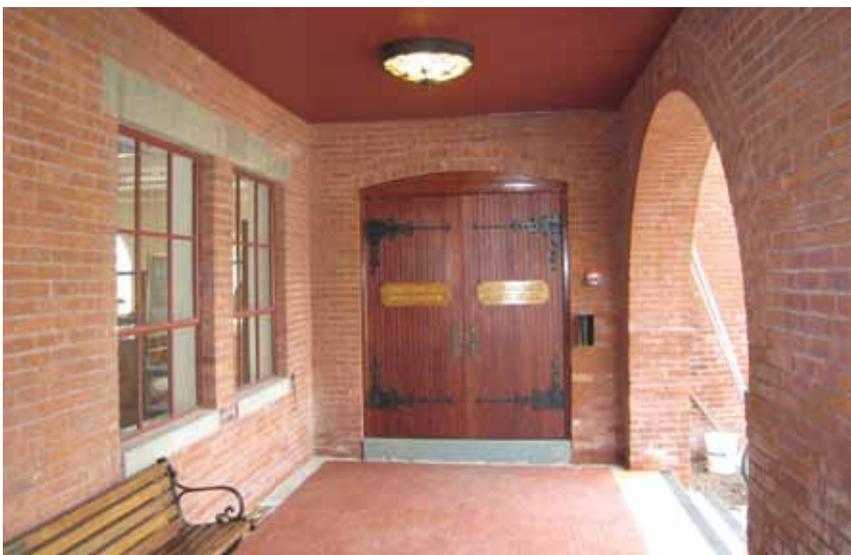
The entry at Ely Hall after restoration now features refurbished windows.

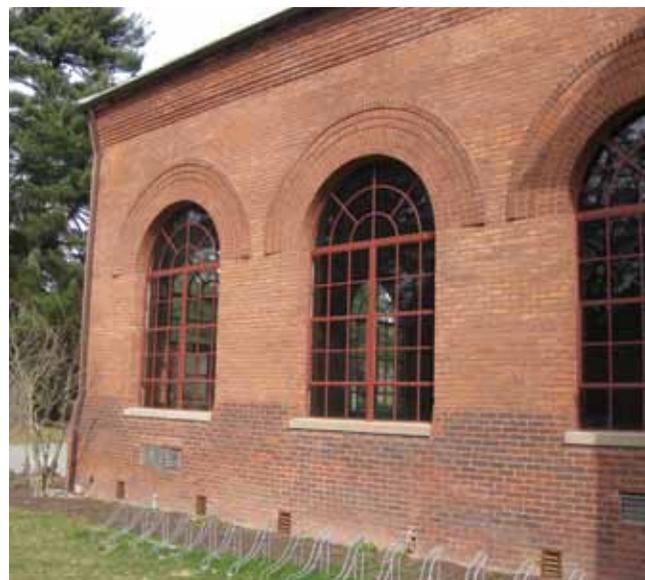
The largest windows at Vassar's Ely Hall are 7x11 ft. All are now restored. Photo: Andy Wilson, CVM

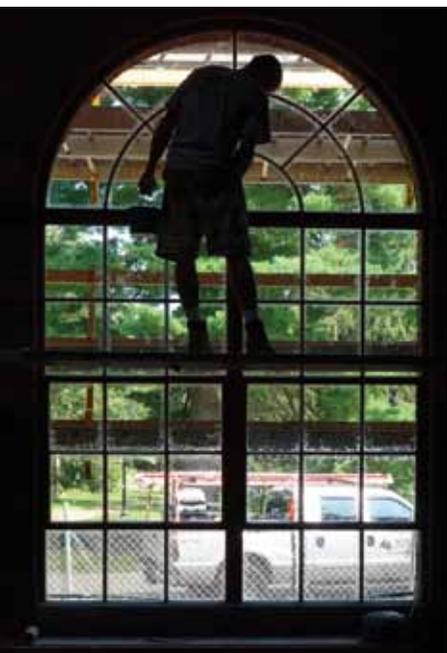
A Seekircher worker paints one of the windows at Ely Hall.

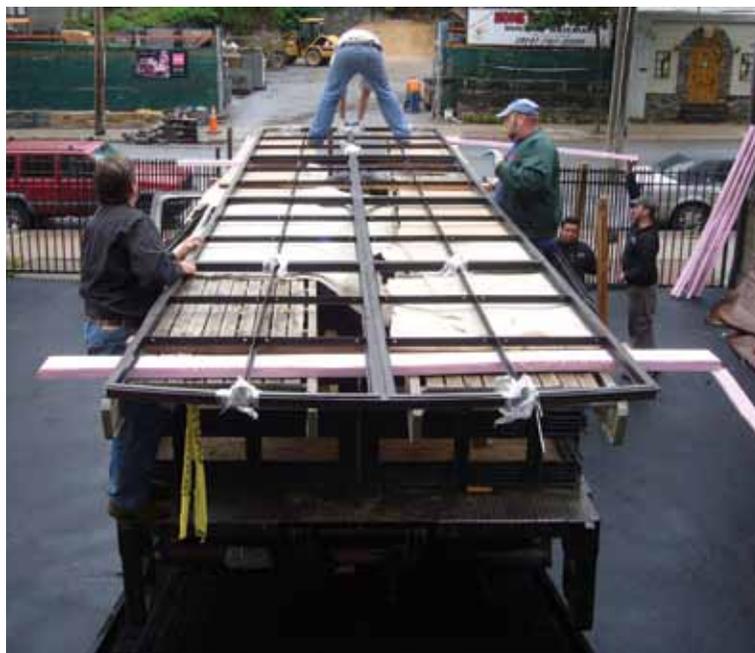
At Columbia University Hospital, the windows were taken out, loaded on to trucks and taken to Seekircher's shop in Peekskill, NY.

The windows were dismantled, loaded into Grenadier trucks and taken to the shop. "We made several trips to the shop to monitor the work and talk about certain repairs," MacDowell notes. "At some point, a decision was made to replace all of the glass rather than just broken panes."

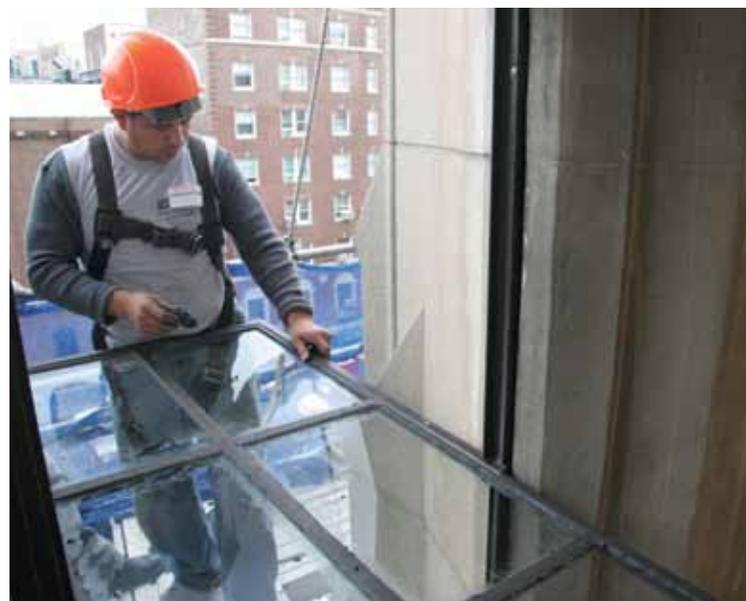
After the Columbia windows were restored in the shop, they were put back in the building where workers installed and putty-glazed the glass. Seekircher worker Omar Hernandez is shown here glazing one of the windows.

Grenadier workmen set the repaired steel windows in place and then Seekircher did the final painting and glazing (1/4-in. laminated glass) on site. "The client was thrilled," says MacDowell. "We got so many comments from people who said they were such beautiful windows. They didn't realize that they were the old windows. Even some engineers thought they looked like new windows. John also added some new hardware. The windows really stood out. It was a big 'wow' factor." **TB**

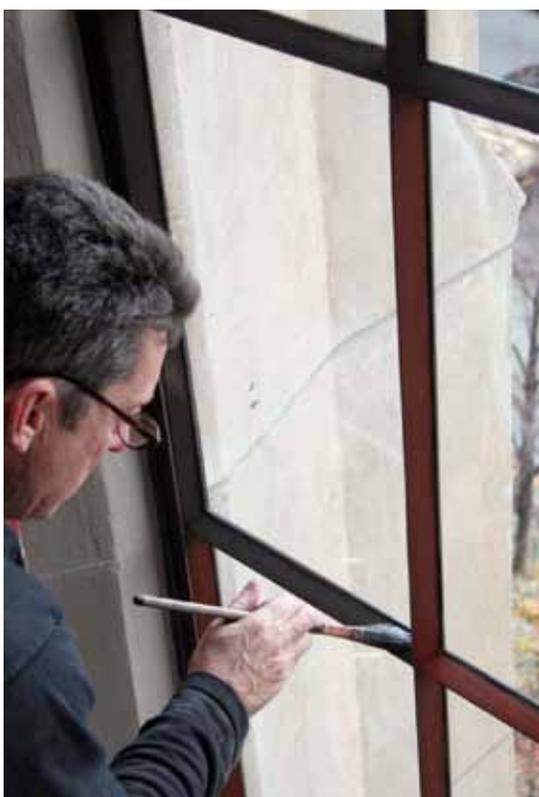
The final step at the Columbia University Hospital project in New York City was painting the windows. Ralph Whitehead of Seekircher applies two coats of paint.

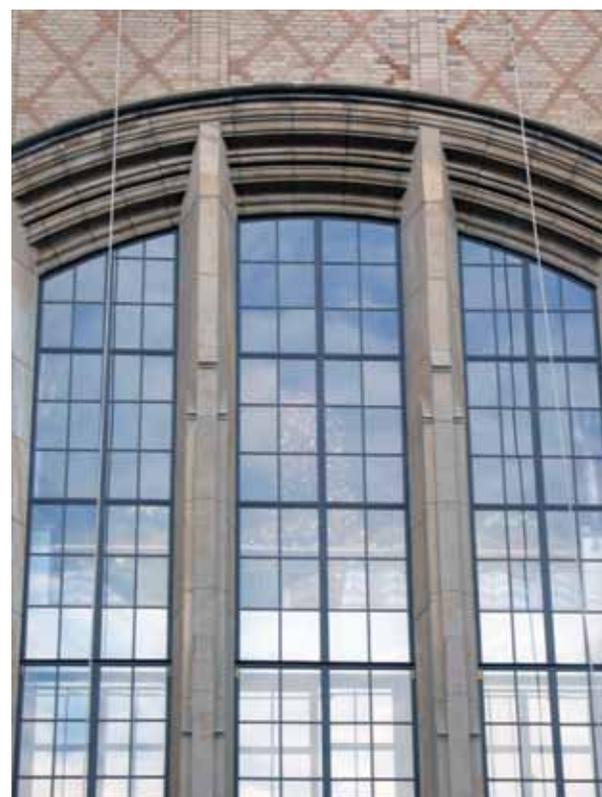
The restored steel windows at Columbia University Hospital now greet visitors as they enter the medical complex. Many viewers thought they were new. Photo: Richard MacDowell, Grenadier Corp.
